# Reinforcement work carried out on the Todolella Parish Church after the collapse of a pilaster supporting the classical style dome; Castellon, Spain.

ABSTRACT: This paper is particularly interesting since it provides unpublished data on the reinforcement carried out in 2006. Cross-sectioned plan and elevation drawings give a detailed account of the geometry, illustrating cracks and strains with precision. The building specifications of walls and masonry shells with poor mortar, the depth and bond of brick arches and the walled vaults and domes are also depicted. Non-linear structural damage models of the fractured structure were made to reproduce the settling of the foundation and its effect on the fracture of structural elements such as the dome, drum and the outer buttress. The paper also describes the stability analysis performed on the damaged construction elements, drum and dome. The criteria and intervention techniques applied and described are supported by the results of these analyses.

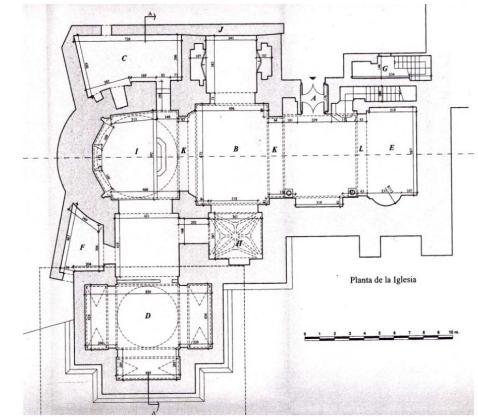
The chapel was in a particularly ruinous state. Due to the collapse of a pilaster, the two main arches resting on it were cracked through, since the pilaster was located close to the keystone. The other two arches only showed fissures, since their supports had not been affected. Two outer walls were also cracked through in parallel with the arches. The main cylindrical drum under the main dome was fractured in the area between the crack in the pilaster and the fracture of the keystone.

Figure 1. Greek-cross plan of the chapel D.

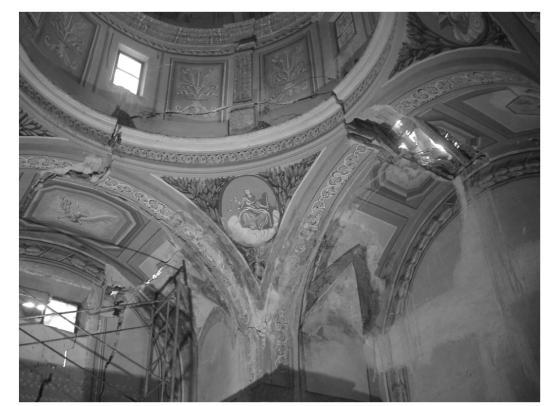
Figure 2. Cracks on the two main arches.

At Points A and D the arches are cracked in the proximity of the key in a very similar way. The drum is completely cracked between the keys of the R and S arches, following the directrix of a load-bearing arch in response to the base of arches R and S.

We ruled out any rectification of the arch, as we preferred to leave visible the joints, the response of the broken structure and its search for balance. But we had to cure the wounds, restore the lost continuity, close the cracks, avoid the entrance of water while leaving testimony of the episode in the building's history.

In the case of the arches with fissures, several coats of dilute lime washes were applied.

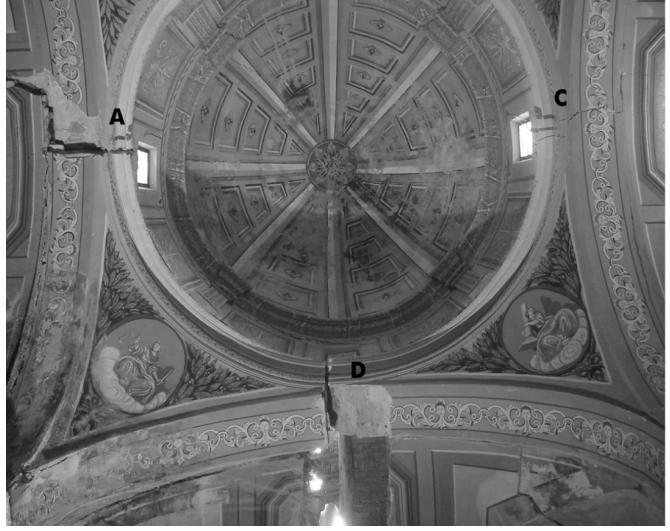
Figure 3. Main dome fractured.

The drum and dome. The techniques described for the consolidation of the rubblework were used. Fissures and cracks were stopped with flexible mortar in such a way as to leave a testimony of the event.

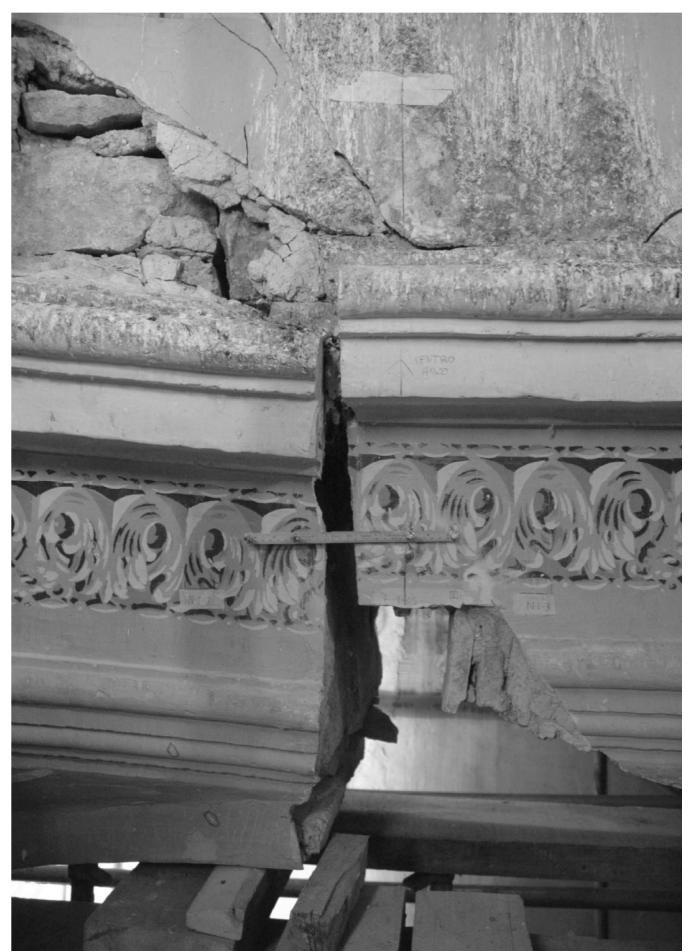
The break at Point A of arch, between Sections 1-2 is clean and has a width, that varies according to height, of between 23mm and 50 mm. In addition, it can be seen that the interior surface of the arch is smaller on the right than the left by 75 mm (central observation point). There is also a radial displacement of 5 mm.

At Point D of arch, here again the break was clean with width of around 200mm, varying according to height. The interior surface of the arch on the left hand side is smaller than the right by 75 mm (central observation point). Radial displacement is 20mm.

Figure 4. arch A cracked in the key.

From the data collected, it is deduced that pilaster, on which arches A and D rest, had descended approximately 75 mm and caused the break in the arches. No settling was detected in the other three pilasters. Analyzing the geometry of the deformation, the agreed interpretation is that the abutment pilaster AD, decreases to precisely the same value as the difference of level on both sides of the crack of the arch. The cause of the fracture, therefore, was attributed to the settling of the foundations due to ground movements.

Luckily, the correct strengthening of the foundations with a reinforced concrete wall eliminated the cause. The slope became stabilized and the foundations of the heavy rubblework walls now properly transmitted their loads onto the lower supporting layers.

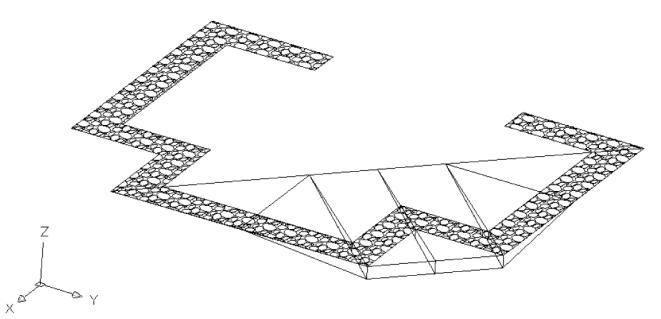
Figure 13. foundation settling planes.

The maximum settling entered was 6 cm. The numerical calculation produced a mechanism in the structure when the corner sinks 3 cm.

In the actual structure, the 7 cm. sinking was measured at the corner. This is because the settling of the foundations follows the failure of the masonry. The model measures up to the moment of failure, that is when the structural mechanism appears.

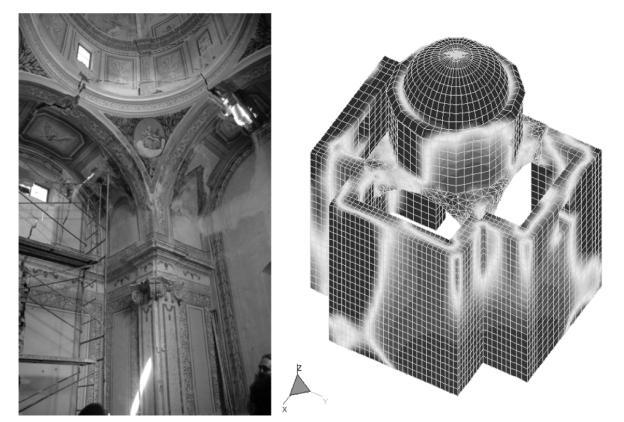
Figure 14. Damage to arches, drum and walls.

The numerical analysis of this sample show that the damaged structure is stable and new mechanisms do not take place. This is consistent with the real structure, which has remained stable since the intervention was carried out.

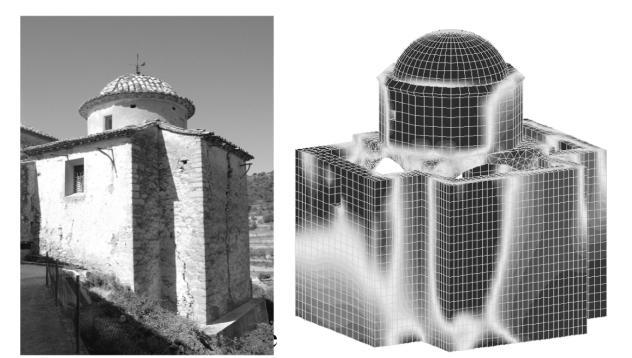
In the outer walls between abutments, there is a break approximately at the center of the wall throughout its width, being wider at the bottom than the top. The third side does not show any cracks. The fourth side does not exist, since it connects the nave with the presbytery.

Figure 15. Cracking of the walls due to gravitational load and settling of foundations.

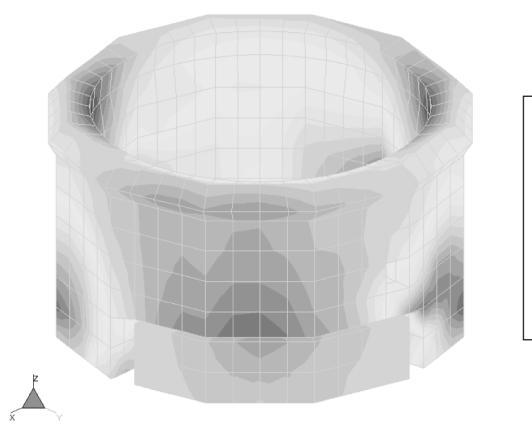
In the part of the drum over the horizontal fissure, a type of load-bearing mechanism is formed, as the horizontal tensions in the previous figure shows. This causes a sort of projection to appear in a curve that remains stable.

Figure 18. Horizontal tensions in the drum.
