# Cover cracking in RC columns subjected to reinforcement corrosion under sustained load

**ABSTRACT:** This paper presents the results of an experimental study wherein circular spirally-reinforced concrete columns were subjected to accelerated corrosion while sustaining a constant service compressive load. Two types of specimens were used in the experimental program: type CV, where vertical reinforcement was corroded and isolated from non-confining spiral reinforcement, and type CS where spiral reinforcement was corroded and isolated from the vertical reinforcement to study the effect of confinement. The cracking initiation, pattern, and widening of the concrete cover were monitored for ten months, and relations obtained between the crack widening and propagation and the elastic shortening of the column and steel mass loss were established. The cracking pattern was found to be wider and in the form of longitudinal cracks along the vertical bars in type CV columns, but more random and distributed over the surface and not as wide in type CS columns.

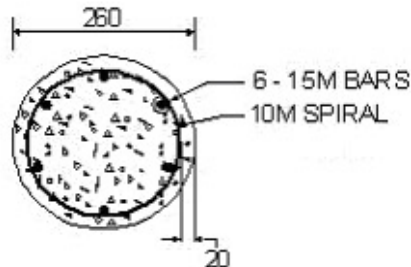
The RC column specimens used in this study consist of a 260-mm diameter circular cross-section reinforced with 6-15M longitudinal bars ( $\phi = 16.0$  mm) and 10M spirals ( $\phi = 11.3$  mm). The concrete cover to spiral reinforcement was 20 mm. The cross-section of the columns is illustrated in Figure 1. The compressive strength of concrete used in the design was 25 MPa, and the steel yield strength used was 400 MPa. Two types of column designs were used in the experimental investigation, with five specimens of each type being built. The difference between the two designs was the spacing of the spiral reinforcement, which was specified to 220 mm for type CV columns, and 80 mm for type CS columns, respectively. The difference in spiral pitch allowed investigating the effect of confinement on the behaviour of corroded columns. Figure 2 shows the reinforcement cage used in the RC specimens.

Figure 1. Details of RC columns' cross-section.

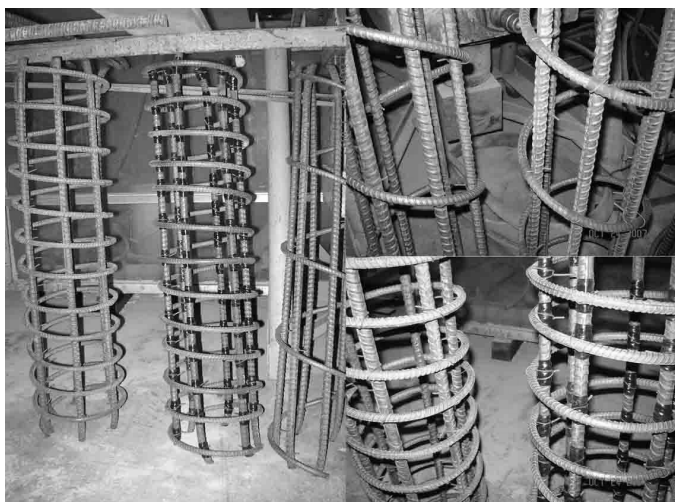
Figure 2. Reinforcement cage used in RC columns.

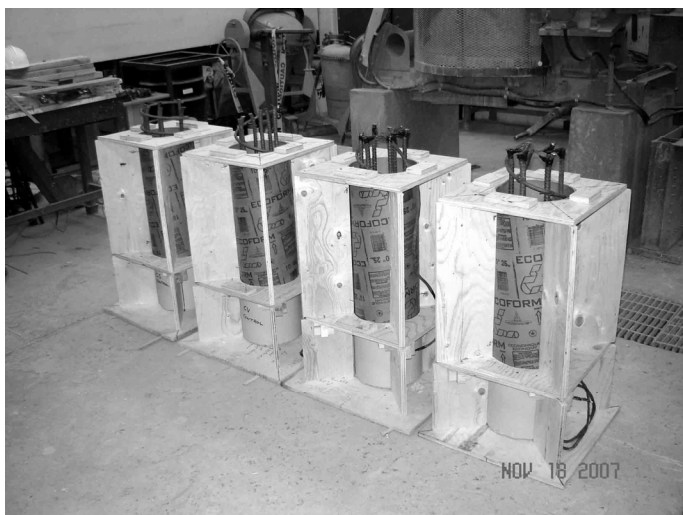
In addition to the concrete compressive strength tests, the high-strength non-shrink grout used in the top and bottom steel caps was also tested. At each of the 5 concrete castings, the casting of grout took place before the concrete casting at the bottom of the cylinders and after the concrete casting at the top of the cylinders. Standard cube samples were taken at each grout casting and tested in compression at 7 and 28 days. The average compressive strength of the grout is 53 MPa. Figure 3 shows the formwork used in the production of the column specimens.

Figure 3. Formwork used in the production of the columns.

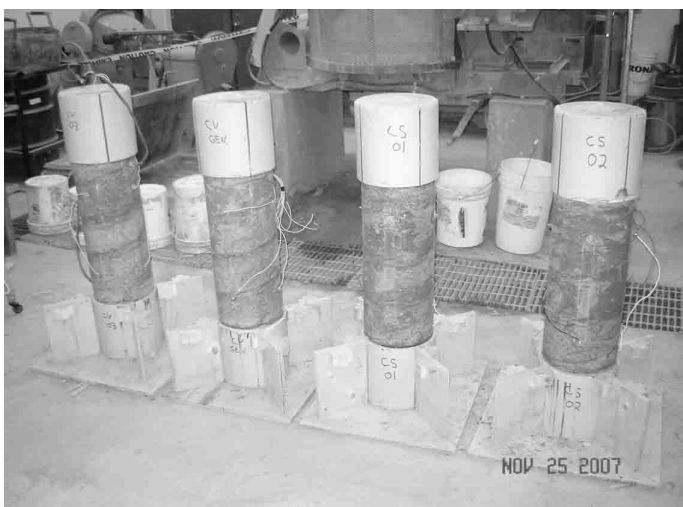
Figure 4. RC column specimens after formwork removal.

Curing was achieved by using moist burlap fabrics, which in turn were wrapped with plastic sheets to minimize evaporation. The specimens were sprayed with water at least once per day in order to ensure sufficient moist conditions for hydration. The curing regime lasted for 14 days after formwork removal. Figure 4 shows the final columns with top and bottom steel caps.

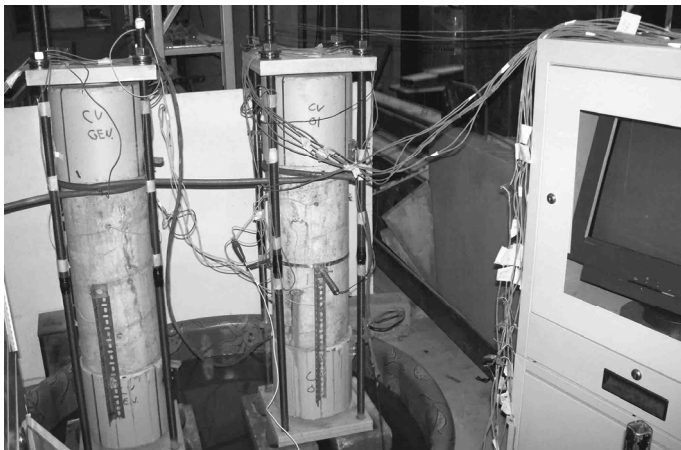
specimens. The current density applied on the specimens ranged between 280 and 315  $\mu\text{A}/\text{cm}^2$ . These current densities are much higher than those recorded in the field (Rodriguez et al. 2000); however, they induce a certain level of damage in a relatively short period of time. Figure 5 shows two specimens in their final setup under load and subjected to accelerated corrosion. In this figure, corrosion staining, which appeared 15 days after the initiation of the accelerated corrosion process, can already be observed at some existing shrinkage cracks on the concrete surface.

Figure 5. Final load and accelerated corrosion setup.

Two 332×332×38-mm steel plates placed at the top and bottom ends and connected with four 25-mm diameter steel rods were used to keep the columns under a sustained axial compression load. The column itself was mounted between the two steel plates with a central high-strength 16-mm thick circular steel plate, which was fully welded to the square plate but not welded to the column cap plates, in order to simulate an axial pin connection. By subjecting the four steel rods to a tensile force, the RC columns were subjected to a constant axial compressive load. The tension steel rods used to apply the load were also painted with a corrosion resistant primer. A tension force of 55 kN was applied at each rod, with a

In order to induce corrosion on the reinforcement, the columns were electrically connected to a PGSTAT100 potentiostat. A constant anodic current density was impressed on the steel reinforcing bars, while four stainless steel sheets (25-mm wide by 400-mm long) were placed directly at the column exterior serving as counter-electrodes. The stainless steel sheets were placed during casting on the wet concrete surface to ensure optimum contact. The reinforcing bars were connected to the electrical wires of the potentiostat by means of welded screws with nuts covered with electrical tape to limit the effects of corrosion at these sensitive points. These connections were also zinc-paint coated for maximum protection. The specimens were further exposed to wetting and drying cycles instead of completely being immersed in water, in order to ensure a sufficient supply of moisture and oxygen for the electrochemical reactions. The wet-dry cycles were applied at constant time intervals with a pump that sprayed water through a perforated hose placed around the columns.

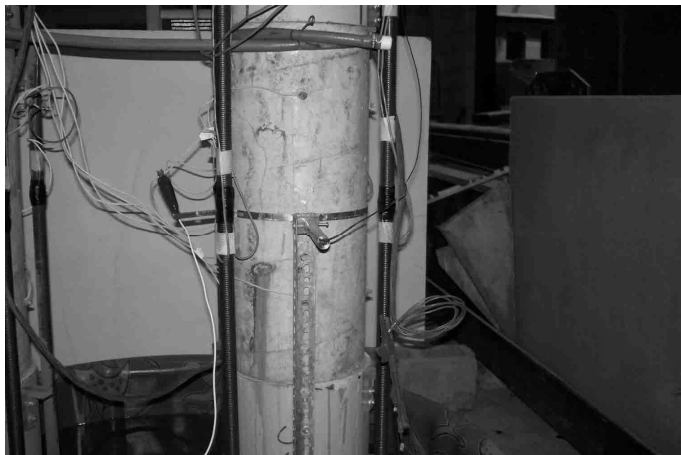
Figure 6. Electrodes and LVDTs of the experimental system.

Strain gauges were placed on the steel tension rods in order to monitor the compression load applied to the columns. Each of the four rods had two strain gauges attached at its centre, with a total of 8 strain gauge readings. In addition, three LVDTs were used to monitor the deformation in the columns. Two LVDTs were used vertically to measure the total shortening of the columns as a result of the compressive load, and the remaining LVDT was used horizontally at column mid-height (placed at an expandable circular thin metal sheet wrapped around the column) to measure the circumferential expansion. Figure 6 shows the electrodes, the perforated hose

used to spray water, the strain gauges, and the LVDTs on an RC column specimen.

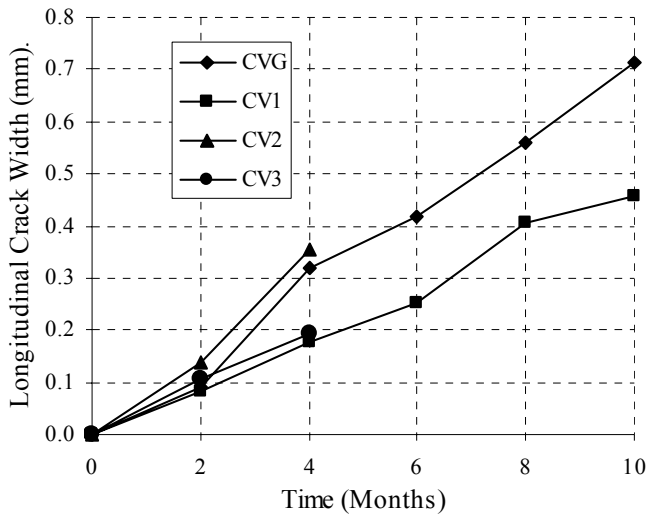
Corrosion damage started to become visible towards the end of the second week of testing for all column specimens. All specimens showed initial discolouring at random spots across the concrete cover surface, with corrosion gel leaking through existing cracks and voids in the concrete. Towards the third week of testing, all column specimens started to show hairline cracks. Specimens type CV showed longitudinal vertical hairline cracking along the location of the vertical reinforcement. By the second month, these cracks had an opening between 0.083 mm and 0.14 mm wide. Figure 7 plots the increase in longitudinal crack widths over time for columns CV. The figure shows the average crack width measured for each specimen. Crack width measurements at areas that appeared to be spalling or almost spalling and were wider than 1 mm are not included

in Figure 7. As observed from the figure, although all specimens experienced an increase in crack widths over time, specimen CVG, whose reinforcement cage was all subjected to accelerated corrosion, displayed the higher values of crack widths after 10 months of exposure.

Figure 7. Longitudinal cracking width over time in columns type CV.

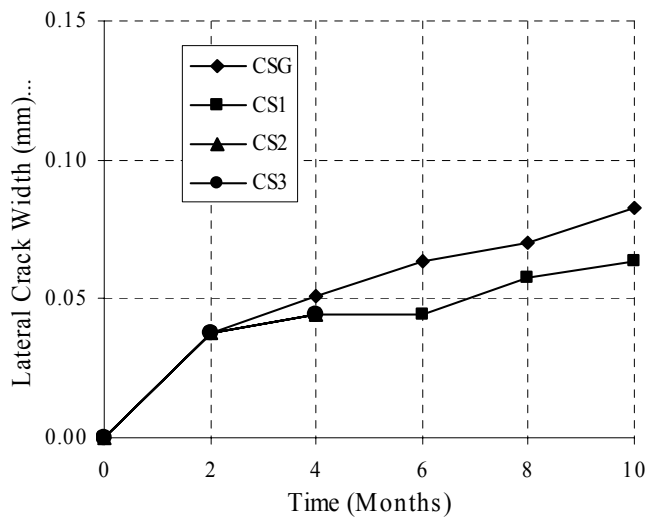
Figure 8. Lateral cracking width over time in columns type CS.

Specimens type CS showed minor hairline cracks going laterally and scattered at various spots across the concrete cover. Although these cracks were continuously leaking corrosion rust product, they were too small and difficult to measure until about the second month of testing. Towards that time, it became possible to insert the 0.038 mm feeder blade in most of the cracks. Figure 8 shows the increase in lateral crack widths over time for columns CS. Figure 8 plots the average crack width obtained for specimens CSG and CS1 for a period of 10 months and for specimens CS2 and CS3 for a period of 4 months. As shown in the figure, these lateral cracks are a lot less wide than the vertical cracks observed

in columns type CV: 0.083 mm was recorded as the maximum lateral crack width for columns type CS as opposed to 0.712 mm as the maximum longitudinal crack width for columns type CV. Figure 9 shows typical surface cracking as observed in these two close-up photos of a longitudinal crack at column CV1 taken at 10 months, and some lateral cracks at column CS3 taken at 4 months.

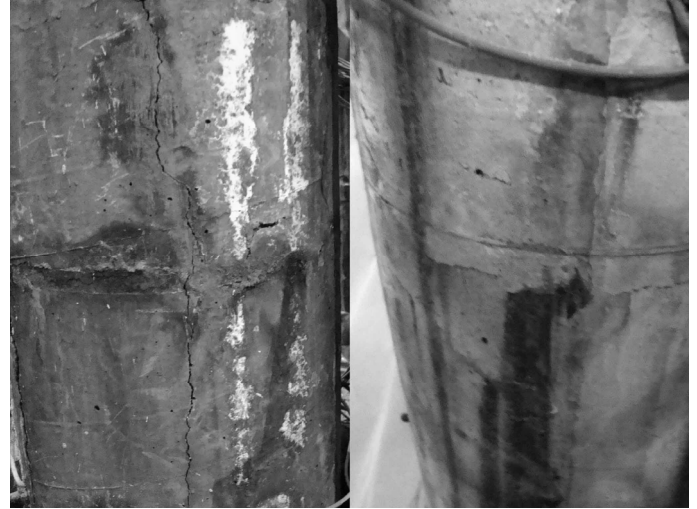
Figure 9. Cover surface cracking (longitudinal).

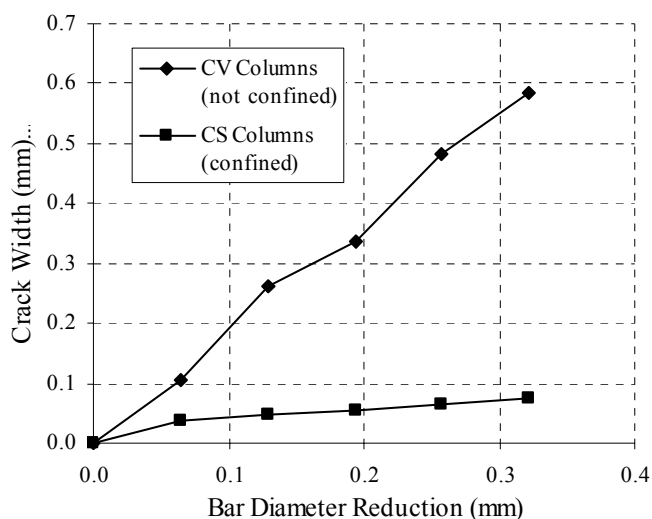
In this investigation, the potentiostat current applied varied between 280 and 315  $\mu\text{A}$ , which translated into a current density of approximately 100  $\mu\text{A}/\text{cm}^2$  applied to the column specimens. Equation 3 was used to calculate the reduction in the reinforcement diameter over the period of simulated accelerated corrosion. Figure 10 plots the average crack width for each column type relative to the reduction in the rebar diameter due to corrosion. The crack width reported in Figure 10 has been calculated as the average of column specimens CV1, CV2, and CV3, and the average of column specimens CS1, CS2, and CS3 over the 10-month period. The graph shows an approximately linear variation of the crack width for both column types relative to the bar diameter reduction. The theoretical maximum bar reduction was calculated to be 0.322 mm at the end of the 10 months period; this implicitly assumes that all the electrical current was used in the corrosion process and that there were no losses. This reduction in the reinforcement diameter will have to be verified through forensic analysis of the corroded reinforcing bars. It can be seen from Figure 10 that crack widths increase approximately linear with time for both column types. A similar trend has been previously observed by Rodriguez et al. (2000).

Figure 10. Average crack width versus bar diameter reduction.

Loads were kept constant on the column specimens during the corrosion simulation. This had a significant impact on the lateral crack propagation. Although the reduction in the reinforcing bar diameter for the testing period was similar for both types of columns (see Fig. 10), the lateral crack widths in columns CS were significantly less than the widths of the longitudinal cracks in columns CV. This was most likely due to the vertical pressure of the sustained loading that is in the perpendicular direction to the lateral cracks, unlike the longitudinal cracks that had little counter-pressure. Therefore, in terms of crack width, the effect of corrosion on spiral reinforcement has a less severe impact on cover cracking than the effect of corrosion of vertical reinforcement in a column. The width of the longitudinal cracks

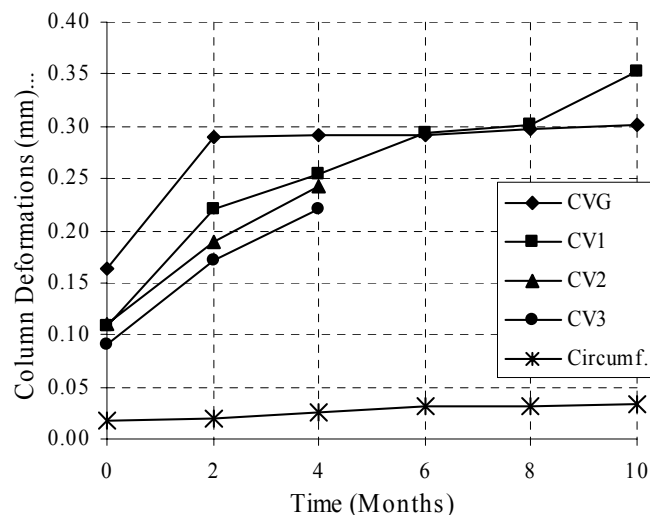
Measurements of the columns' vertical shortening and circumferential expansion were also regularly monitored and recorded through the data acquisition on the LVDTs. Figure 11 shows the average values for the vertical and circumferential deformations in mm during the testing period for columns type CV. From the figure, it can be observed that column CVG, whose entire reinforcement was subjected to corrosion, experienced most of its vertical deforma-

tion in the first two months and stabilized after that, while column CV1 displayed a continuous increase of its axial deformation during the entire testing period. Although columns CV2 and CV3 were only exposed to accelerated corrosion for four months, their rate of column deformation increase is similar to column CV1. The rate of increase of the circumferential expansion was very low for a period of 10 months.

Figure 11. Column deformations over time for columns CV.

Figure 12 plots the deformations versus time in columns type CS. By comparing Figures 11 and 12, it is observed that deformations in columns CV as well as the rate of their increase over time were higher than columns CS. For the latter group, vertical deformations appear to plateau slightly after 3 months of testing, before they start increasing again

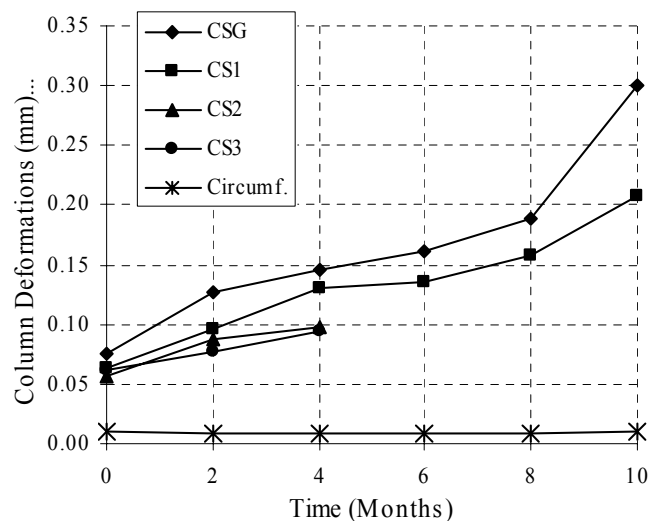
Figure 12. Column deformations over time for columns CS.

at 8 months. The circumferential expansion was relatively smaller than that of columns CV. In fact, it is concluded from the results that column expansion is further increased as the area of longitudinal reinforcement participating in the resistance of the axial load is decreased due to corrosion.

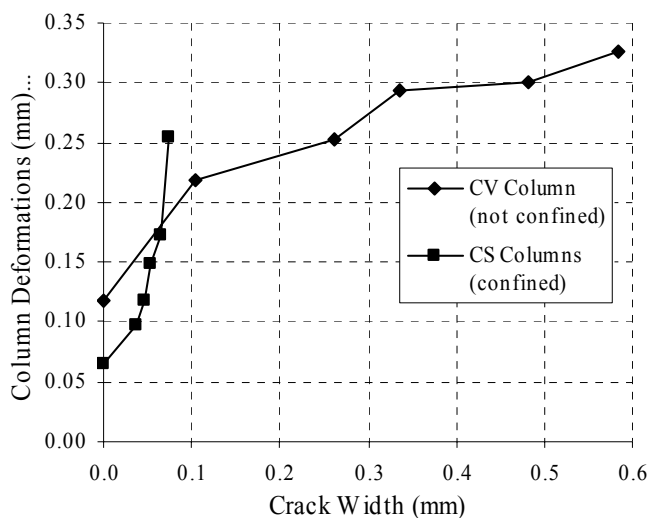
Figure 13 shows the vertical shortening obtained in mm for both column types versus the crack width. Although deformations obtained for columns CV were higher than those obtained for columns CS, the increase in vertical deformation as a function of crack opening is more pronounced for columns CS. The combined effect of corrosion of spiral reinforcement and concrete cover cracking considerably reduces the confinement action in columns CS. This type of columns require less crack opening to achieve a similar level of axial deformation than columns CV.

Figure 13. Vertical shortening versus crack width.
