# Reinforcement work carried out on the Todolella Parish Church after the collapse of a pilaster supporting the classical style dome; Castellon, Spain.

ABSTRACT: This paper is particularly interesting since it provides unpublished data on the reinforcement carried out in 2006. Cross-sectioned plan and elevation drawings give a detailed account of the geometry, illustrating cracks and strains with precision. The building specifications of walls and masonry shells with poor mortar, the depth and bond of brick arches and the walled vaults and domes are also depicted. Non-linear structural damage models of the fractured structure were made to reproduce the settling of the foundation and its effect on the fracture of structural elements such as the dome, drum and the outer buttress. The paper also describes the stability analysis performed on the damaged construction elements, drum and dome. The criteria and intervention techniques applied and described are supported by the results of these analyses.

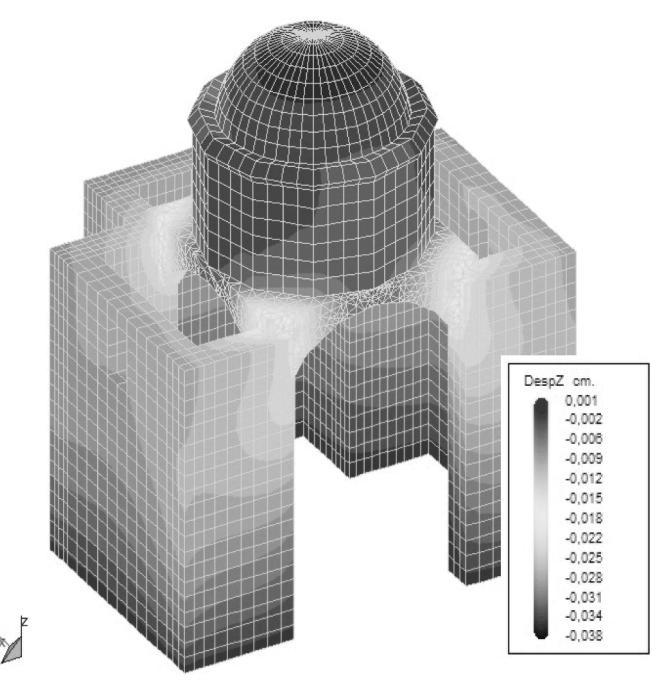
From the linear analysis carried it can be concluded that the structure is very rigid and the deformation level is very low. Maximum deformation is less than 1 mm in the dome.

Figure 9. Vertical deformations for the weight of the structure.

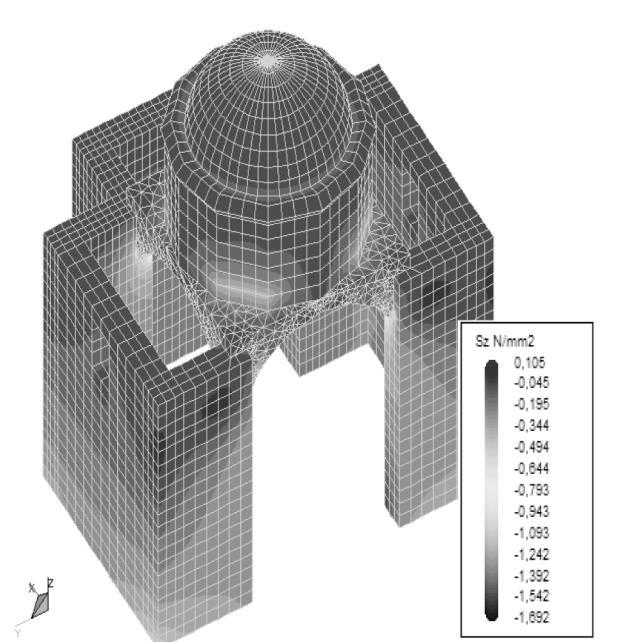
The levels of deformation, tension and damage resulting from the nonlinear analysis for the total gravitational load are shown in the following figures.

Figure 10. Rank of nonlinear vertical tension for total gravitational load.

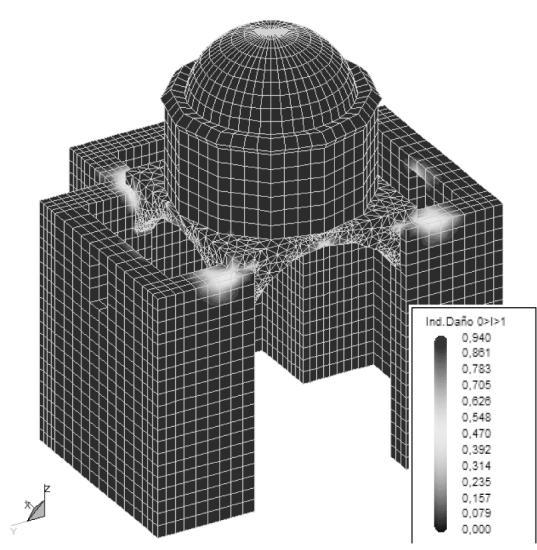
Figure 11. Damage indices in all the structure for total gravitational load.

The damage index graphs show very few zones with traction fissures. These are typical fissures in vaulted structures, such as the keys of the arches and where these are joined to the walls.

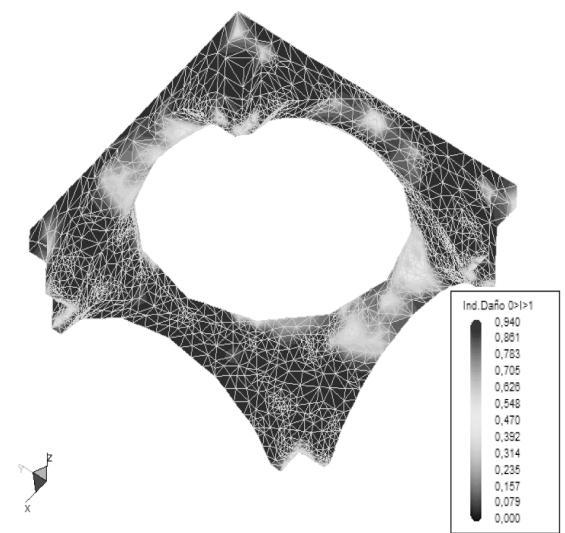
Figure 12. Damage indices in arches and pendentives for total gravitational load.

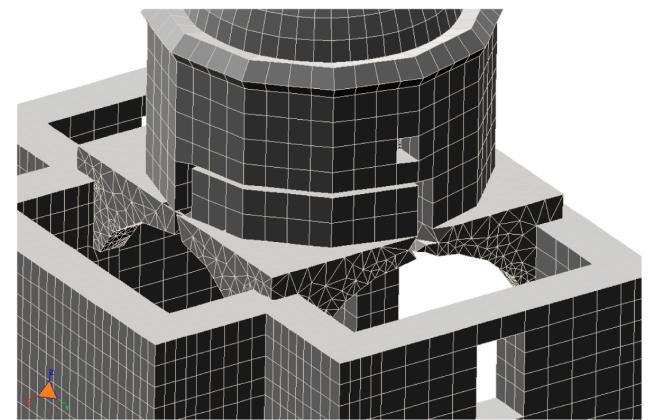
A model of the building was constructed that reproduced in the mesh the fissures of the structure, with breaks in the zone of arches and drum.

Figure 16. Mesh reproducing the fissures with breaks in the archs.

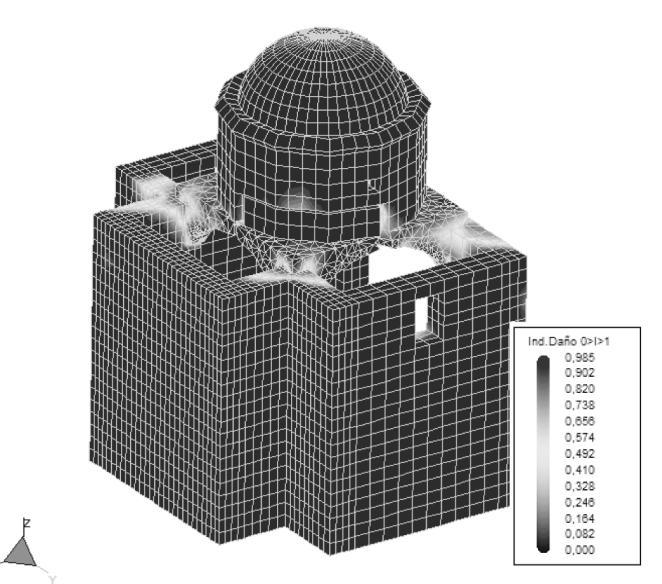
The numerical analysis of this sample show that the damaged structure is stable and new mechanisms do not take place. This is consistent with the real structure, which has remained stable since the intervention was carried out.

Figure 17. Model of damage applied to the mesh modified by the fissures.
